ORNL/Sub/85-28611/2

**OAK RIDGE
NATIONAL
LABORATORY**

**IMPACT OF STEEP-FRONT SHORT-DURATION
IMPULSE ON ELECTRIC POWER
SYSTEM INSULATION**

**PHASE II: LABORATORY EVALUATION OF
SELECTED POWER SYSTEM COMPONENTS**

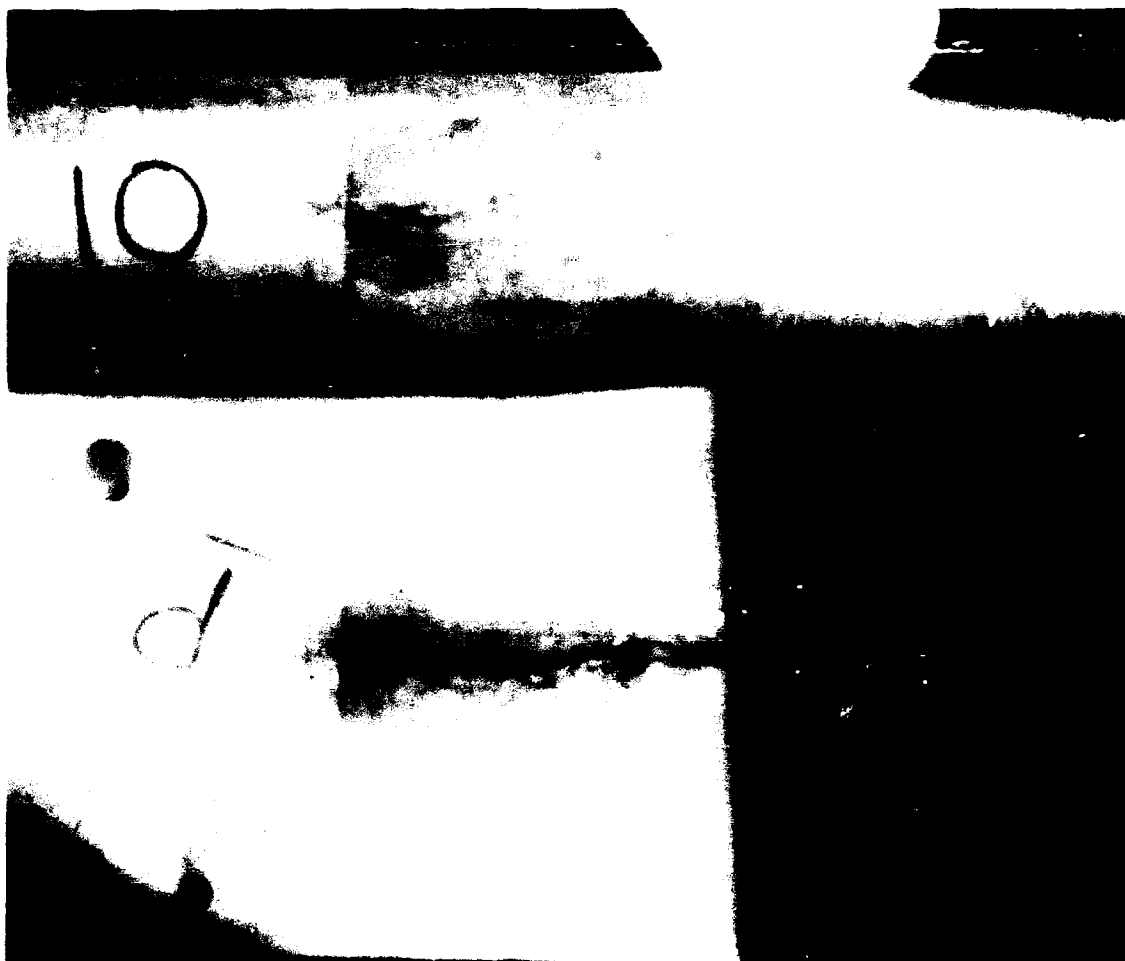
Fig. 3.34. Tracking between layers of cellulose paper insulation, starting at the edge of the potential tap foil.

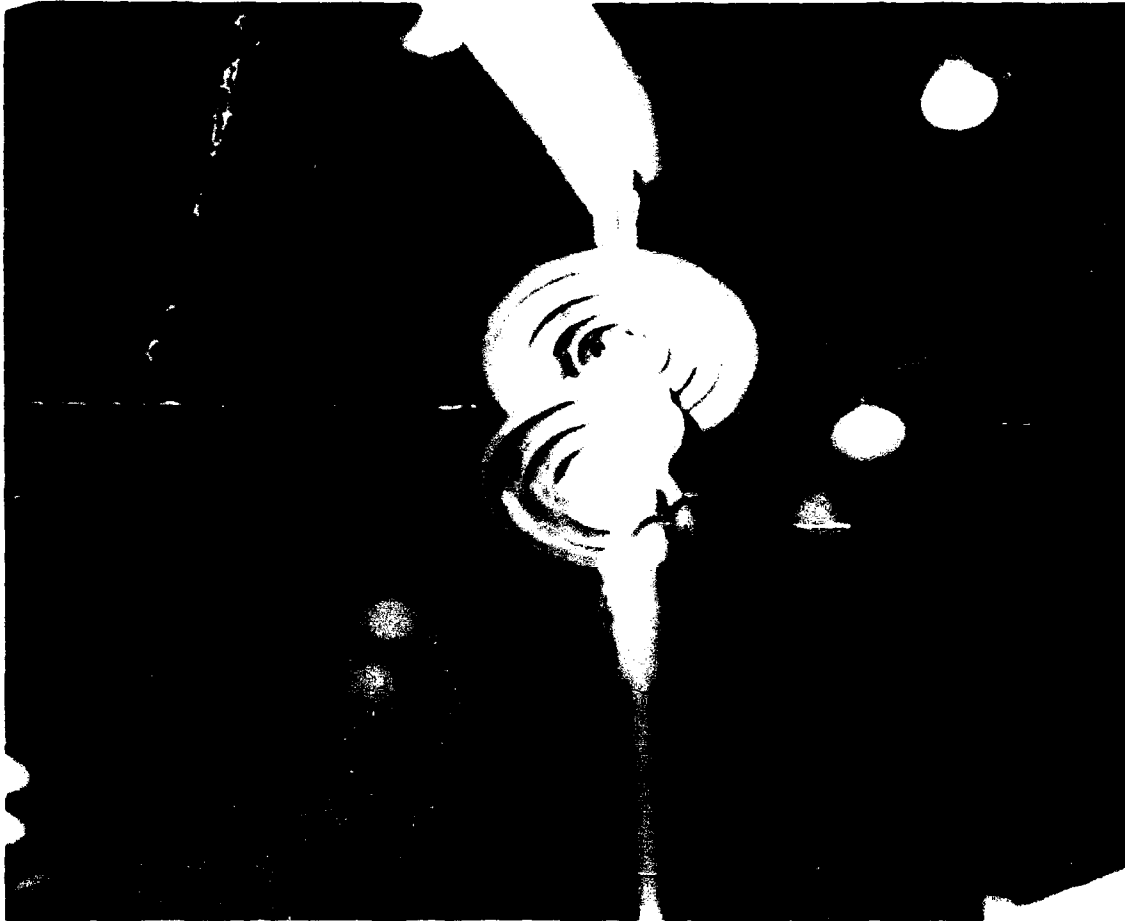
Fig. 4.15. Severe damage to the suspension-disk specimens without the line dropping.
